Data Structure Report No. 103

Excavations at Arney, Co. Fermanagh

**Excavations at Arney, Co. Fermanagh**

**AE/14/01E**

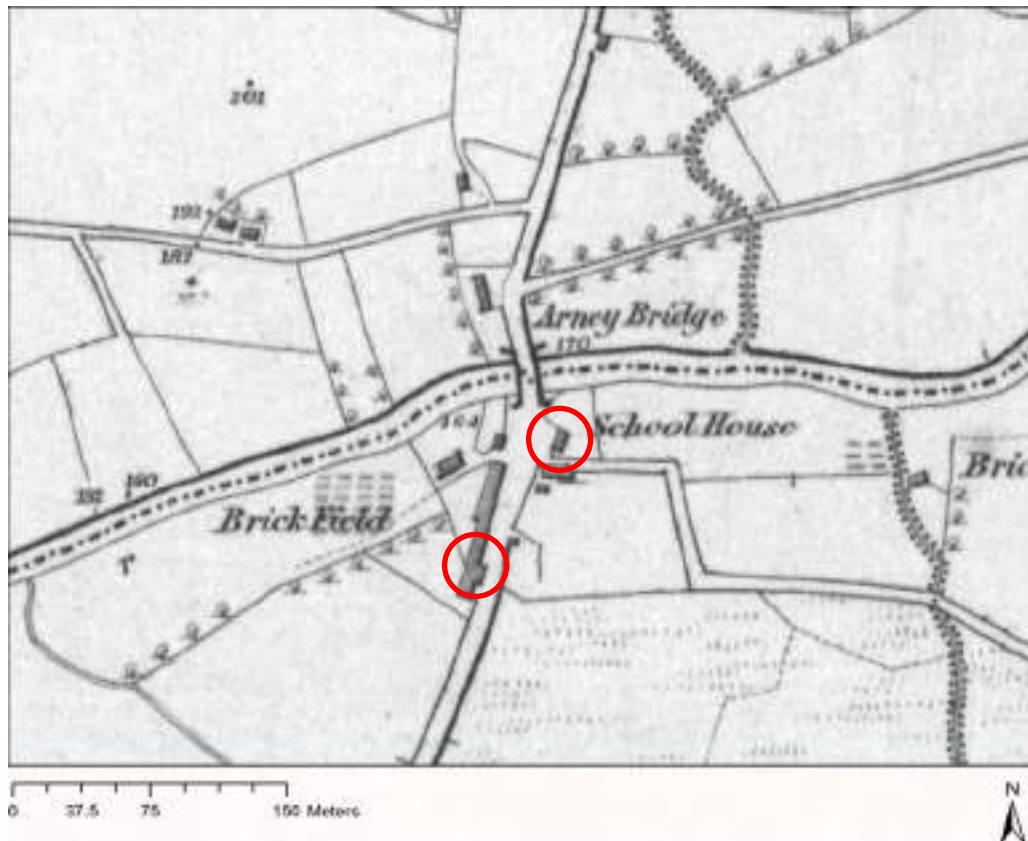
**Figure 3: Excerpt of the 1<sup>st</sup> edition 6 inch OS map dated to 1835. The schoolhouse and cottages are circled red.**

3) dating to 1835. This map shows the schoolhouse to the immediate south-east of the bridge, orientated approximately south-west/north-east. It is apparent that the schoolhouse is set back from the bridge, at a widening of the road. The road is known to have been in use in the early modern period for the Enniskillen bound stagecoach and a settlement may have grown up around the bridge (Eddie Brogan *pers comm.*).

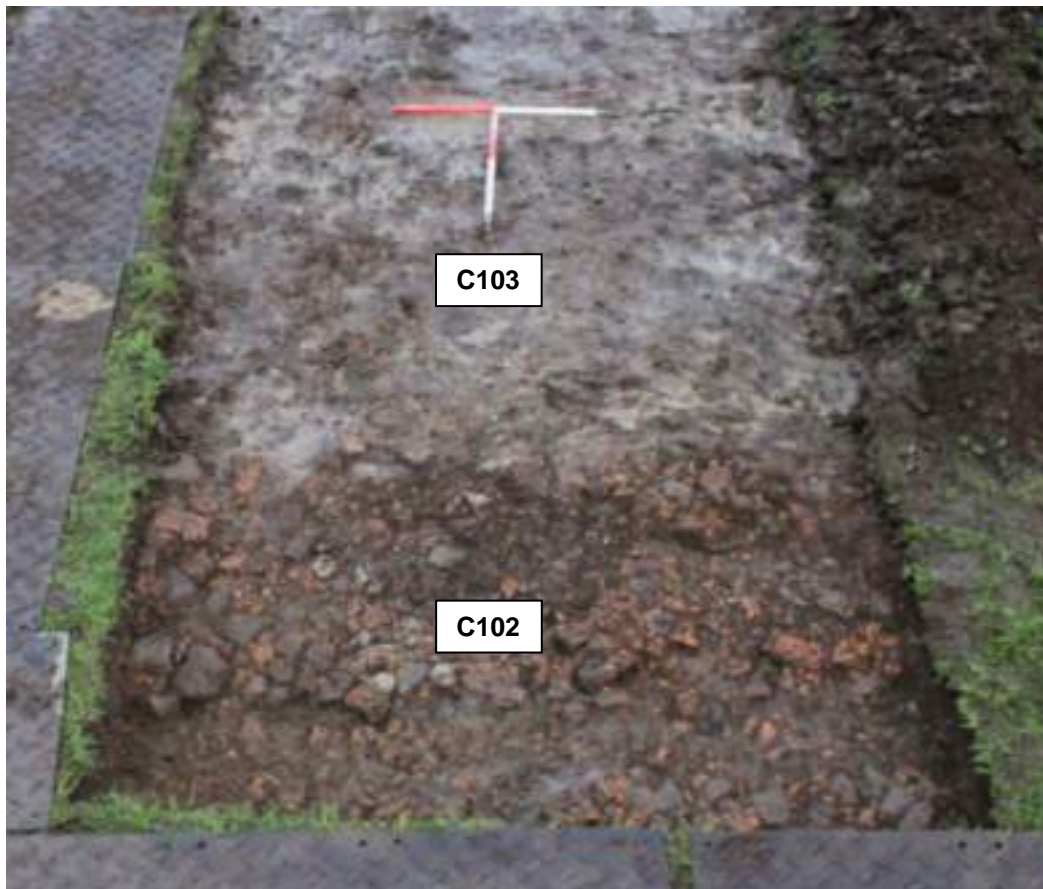
**Plate 1: View of probable demolition deposit (Context No. 102), looking east.**

being deposited following the drain being in-filled (see below). This deposit (Context No. 102) overlay the fill of two negative features (Context Nos. 114 and 116).

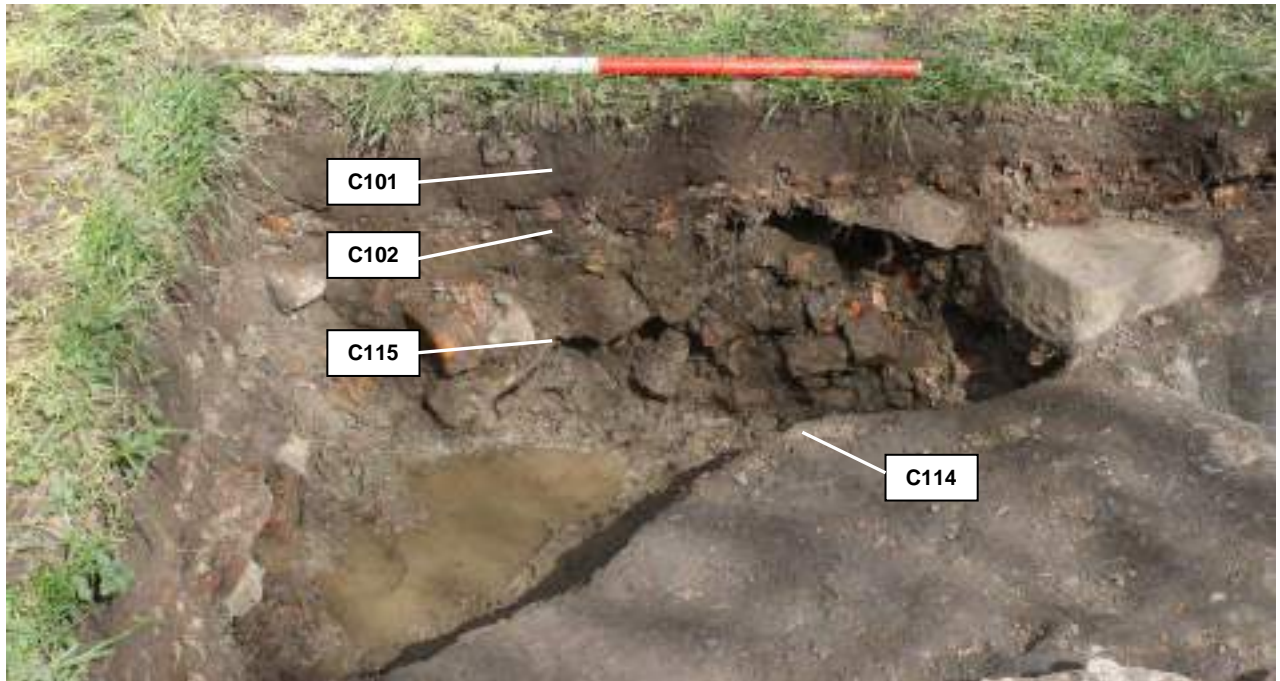
**Plate 2: Western end of the south-facing section of Trench One, illustrating the relationship between the Field Drain (Context Nos. 114/115) and layer of fragmented brick (Context No. 102), looking north. NB water lying at the base of the cut (Context No. 114) of the drain and the rubble fill (Context No. 115) noticeable in the section face.**

- 3.3.4 In the extreme western end of the trench, the demolition deposit (Context No. 102) overlay the fill (Context No. 115) of a relatively shallow cut (Context No. 114). The fill of this feature comprised a soft grey brown silty clay with abundant complete and fragmentary bricks, and occasional patch of mortar throughout. The fill (Context No. 115) was loose in nature and there was no apparent effort to lay the bricks in any coherent manner. Following the excavation of the fill (Context No. 115), water was observed at the base of the cut (Context No. 114) and it is assumed that this feature represents a field drain that was opened following the demise of the schoolhouse building (hence the fill being comprised of building rubble). The cut of the field drain (Context No. 114) had steep to near-vertical sides and a flattish base. The field drain (Context No. 114) was aligned roughly north-east/south-west with only the south-eastern edge of the feature being encountered in the trench. The maximum recorded dimensions for the field drain are 1.4m (east/west) by 0.82m (north/south). The drain was a maximum of 0.48m deep and had been cut into a layer of demolition rubble (Context No. 111) which consisted of a reddish brown firm clay loam. The maximum recorded dimensions of this layer (Context No. 111) were 2.9m (east /west) by 2.8m (north/south) and it had a maximum thickness of 0.23m.

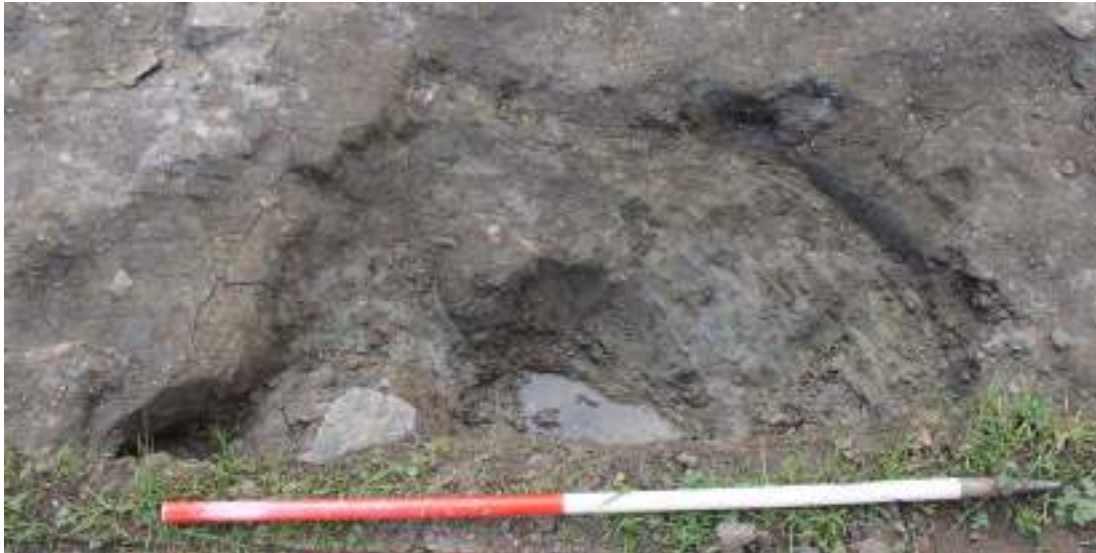
**Plate 3: Post-excavation view of shallow pit (Context No.116), looking south.**

- 3.3.5 The fragmented brick deposit (Context No. 102) also overlay the upper fill (Context No. 117) of a shallow pit (Context No. 122). This deposit (Context No. 117) consisted of a firm brownish grey sandy clay, containing frequent small brick fragments as well as the occasional fleck of charcoal and mortar. The deposit measured 1.86m (east/west) by 0.7m (north/south), had a maximum thickness of 0.31m and directly overlay a deposit of tenacious yellowish green clay (Context No. 122) which comprised the basal deposit of the shallow pit (Context No. 116). The pit was excavated through the beaten clay floor of the schoolhouse (Context No. 103) and overlain by the brick-fragment rich sandy clay (Context No. 102).

- 3.3.6 The tenacious yellow clay (Context No. 122) measured 1.09m (east/west) by 0.46m (north/south) and had a maximum thickness of 0.13m. The deposit (Context No. 122) was relatively sterile save from the very occasional small rounded stones (average size 30mm x 20mm). The cut of the pit (Context No. 116) was sub circular in plan with gently sloping sides to an irregular, slightly concave base. Although the feature carries on into the section, the dimensions of the pit were 1.91m (east/west) by 0.69m (north/south) with a maximum depth of 0.46m. No artefacts were recovered from either fill (Context Nos. 117 and 122) of the pit (Context No. 116).

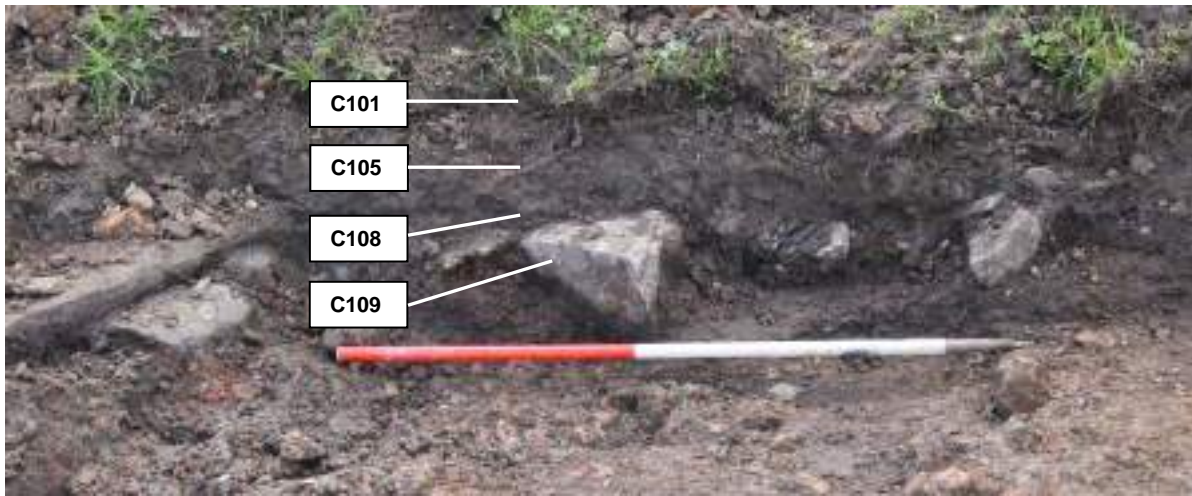
**Plate 4: Eastern portion of the north-facing section showing the large angular stone deposit (Context No. 109)**

the ground for a previous, now blocked up and disused, entrance into the field. The deposit of angular stones (Context No. 109) measured 0.82m (north/south) by 3.2m (east/west) and averaged 0.3m thick.

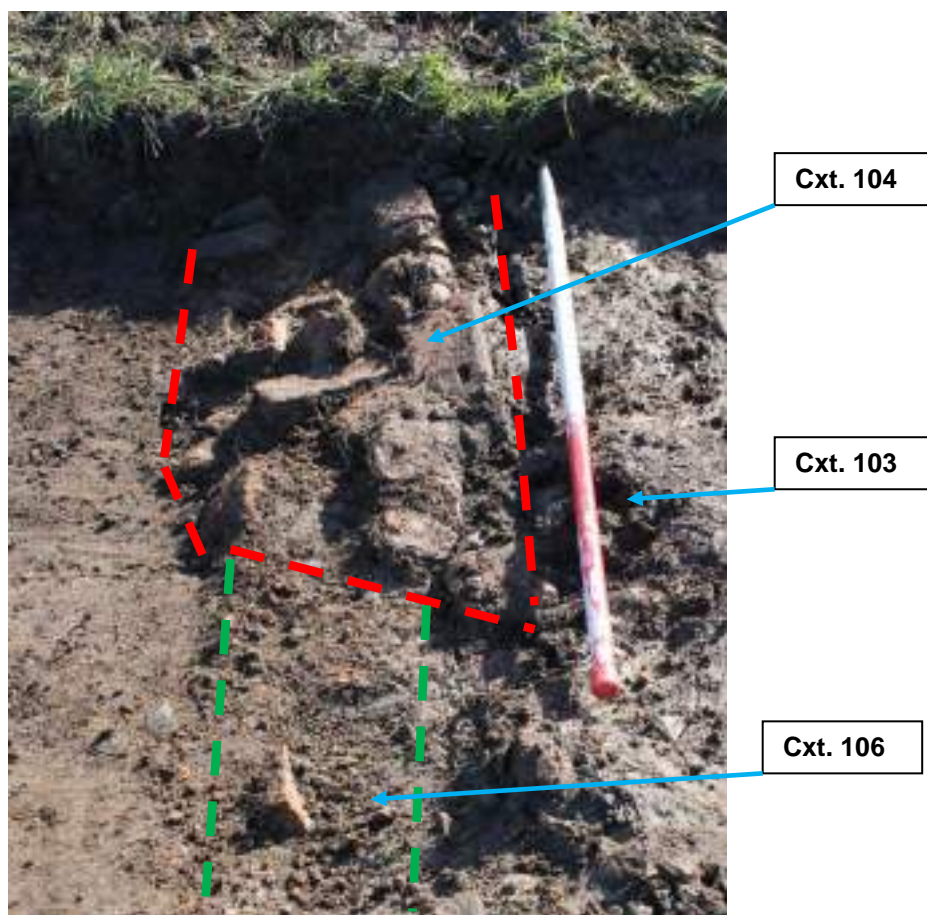
**Plate 5: Tumbled brick linear (Context No. 104) looking south-east. Illustrated is the association between this tumble (Context No. 104), the clay floor (Context No. 103) and the remnants of the rear wall of the schoolhouse (Context No. 106).**

- 3.3.10 Removal of the sod and topsoil (Context No. 101) also revealed a tumbled linear of four complete bricks (Context No. 104). This feature (Plate 6) was aligned roughly north-west/south-east and directly overlay the beaten clay floor of the schoolhouse (Context No. 103 – see below). The feature measured 1.3m (north/south) by 0.4m (east/west) and was one course thick. The bricks did not appear to be bonded together, and may represent an episode of tumble from the rear wall of the schoolhouse (Context No. 106 – see below).

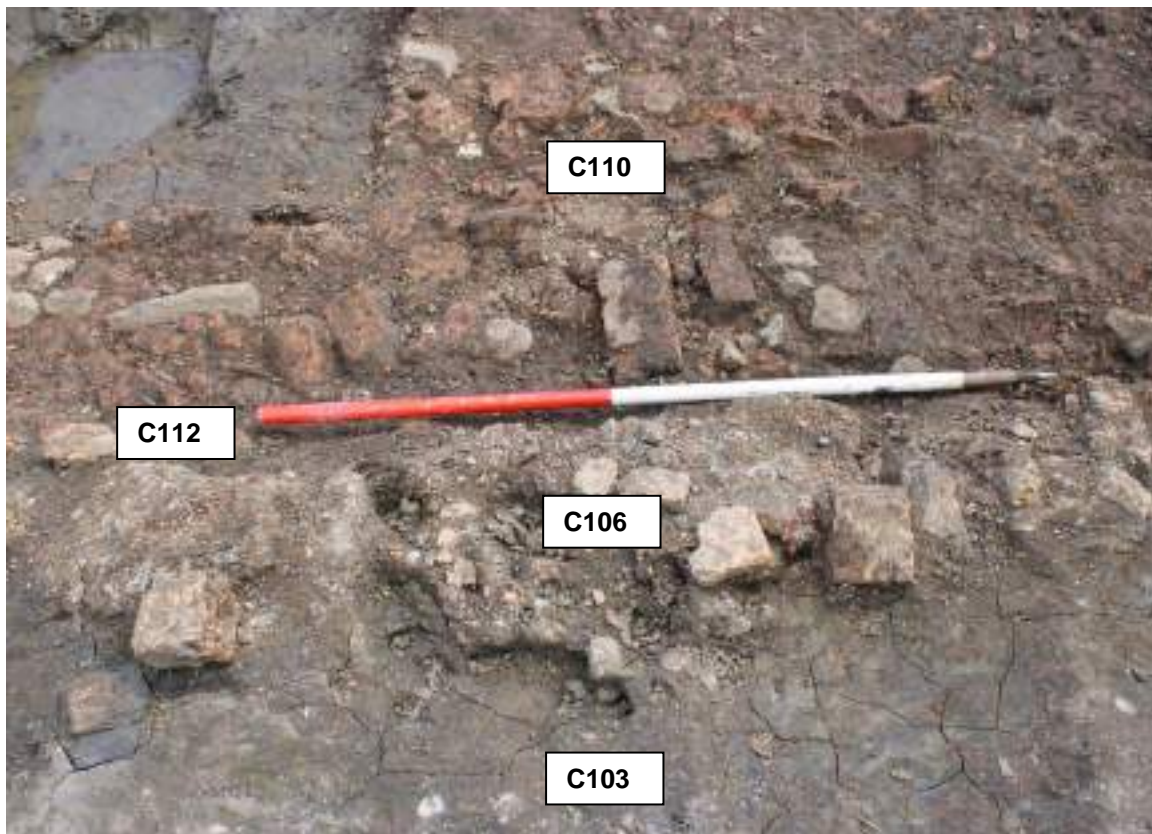
**Plate 6: Remnants of the rear wall of the schoolhouse (Context No. 106), looking east.**

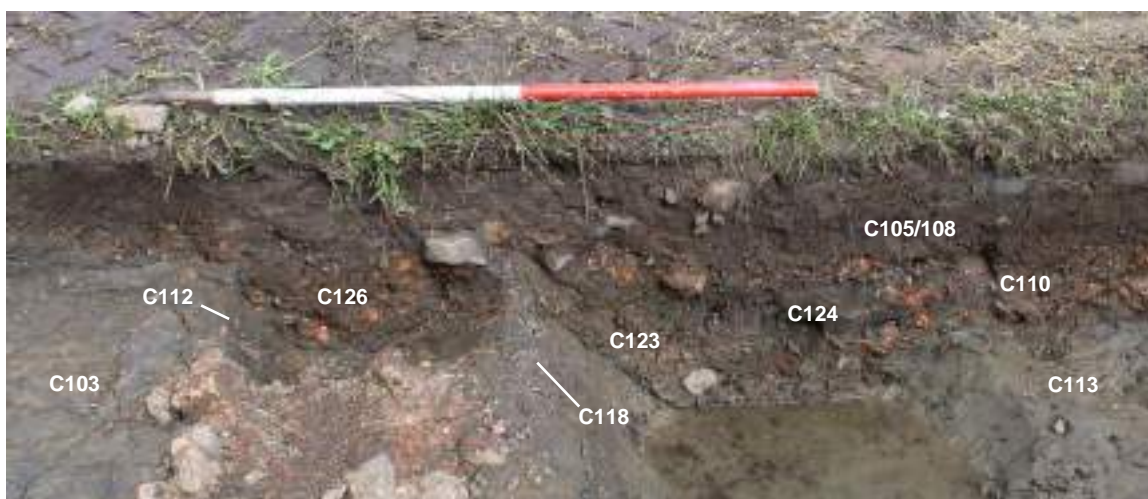
**Plate 7: Eastern portion of the south-facing section, showing the drain (Context No. 112) and fill (Context No. 126), as well as the possible rubbish pit (Context No. 118) and associated fills (Context Nos. 123 and 124).**

3.3.15 In the eastern end of the trench, the removal of the demolition deposit (Context No. 110) revealed features associated with the rear of the schoolhouse including the truncated remains of a wall (Context No. 106), a drain (Context Nos. 112/126) as well as a possible rubbish pit (Context Nos. 118/123/124). The rear wall of the schoolhouse (Context No. 106) consisted of a roughly north/south aligned linear of mortar and fragmentary bricks (Plate 6). This spanned the width of the trench (3m north/south) and was on average 0.38m wide (east/west). This deposit (Context No. 106) was a maximum of 0.16m thick and directly overlay the subsoil (Context No. 113). Adjacent to the wall (Context No. 106), and running directly parallel to it, was a shallow negative feature (Context No. 112) which is interpreted as a small drain that may have directed runoff rainwater from the roof of the schoolhouse. The cut of the drain (Context No. 112) had shallow sloping sides and a concave base and measured 3m (north/south) by 0.4m (east/west) and approximately 0.3m deep. The fill of the drain (Context No. 126) consisted of a friable mid to dark brown sandy clay with frequent inclusions of fragmented brick and small rounded stones. It is possible that the fill of the drain (Context No. 126) originated from the overlying demolition deposit (Context No. 110).

3.3.16 To the immediate east of the drain (Context No. 112) a shallow pit was encountered (Context No. 118). This feature was sub-rectangular in plan with relatively gently sloping sides and concave base. The cut of the pit (Context No. 118) measured 0.82m (east/west) by a maximum of 0.6m (north/south), although this is not the full dimensions of the feature as it continues into the south-facing section of the trench. The pit (Context No. 118) was a maximum of 0.47m deep and was filled by two deposits (Context Nos. 123 and 124). The stratigraphically earliest of these fills was a deposit of tenacious mid brown clay (Context No. 123) with frequent inclusion of small angular stones (average size 40mm x 60mm) as well as the occasional fleck of charcoal. This deposit was only encountered along the western edge of the feature and was on average 0.18m thick. The mid brown clay (Context No. 123) was overlain by a dark greyish brown silty loam (Context No. 124) that comprised the upper fill of the feature (Context No. 118). The silty loam deposit (Context No. 124) was friable in nature with inclusions of flecks of charcoal and small rounded stones frequent throughout. The excavation of this deposit (Context No. 124) produced numerous sherds of pottery and animal bone (as well as a possible fragment of eggshell) and was a maximum of 0.47m thick. This feature is interpreted as representing a rubbish pit associated with the use of the schoolhouse.

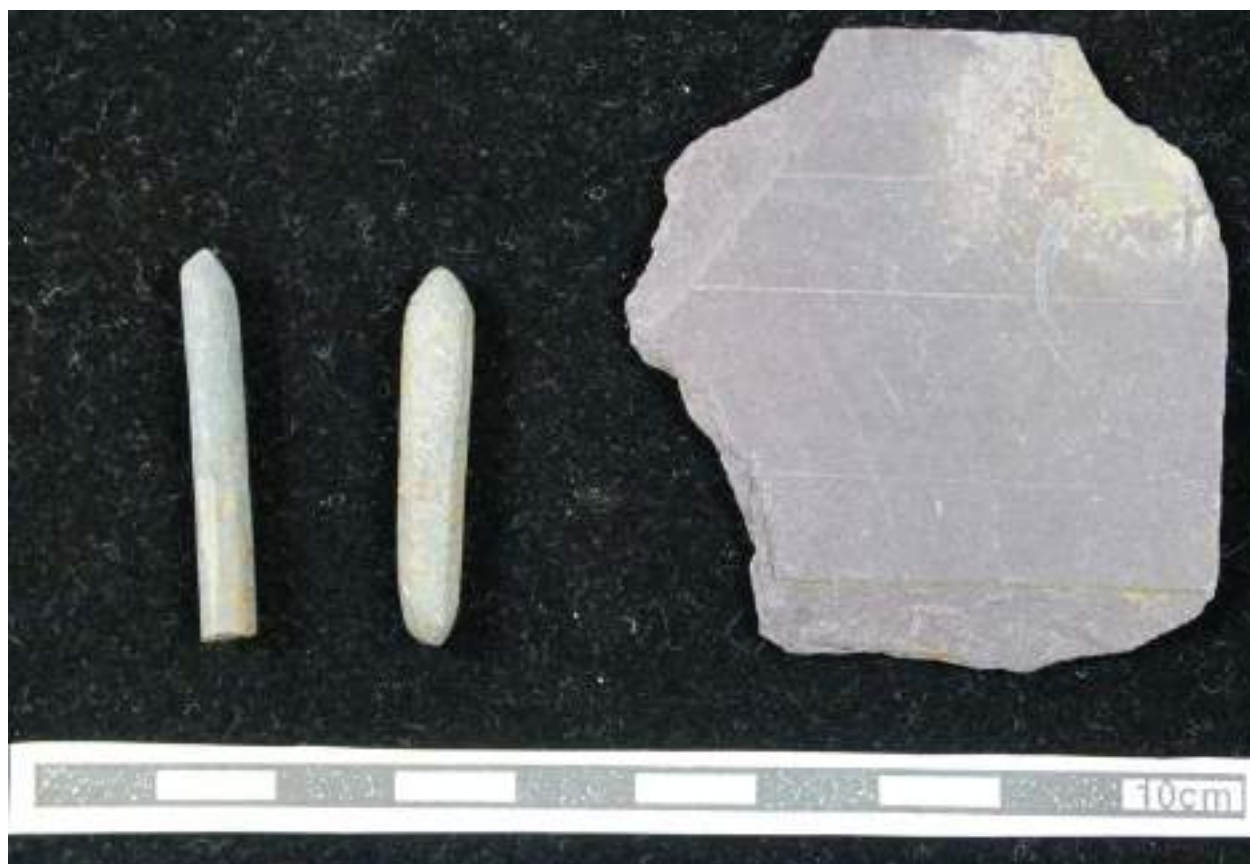
Plate 9: Incised writing slate and styli recovered from Trench One Context No. 103 (scale 10cm).

3.3.25 A number of artefacts were recovered during the excavation of Trench One can be directly aligned to its use as a schoolhouse. The majority of these finds were recovered pressed into the surface of the clay floor (Context No. 103) as well as from deposits associated with the demolition of the structure (Context Nos. 102, 104 and 110). The artefact assemblage includes sherds of nineteenth century ceramics (including several pieces of locally produced '*Florencecourt Ware*' of probable mid to late nineteenth century date), fragments of glass and corroded iron objects. Several artefacts associated with the use of the structure as a schoolhouse were recovered including fragments of writing slates and styli (Plate 13) as well as a fragment of an inkpot.

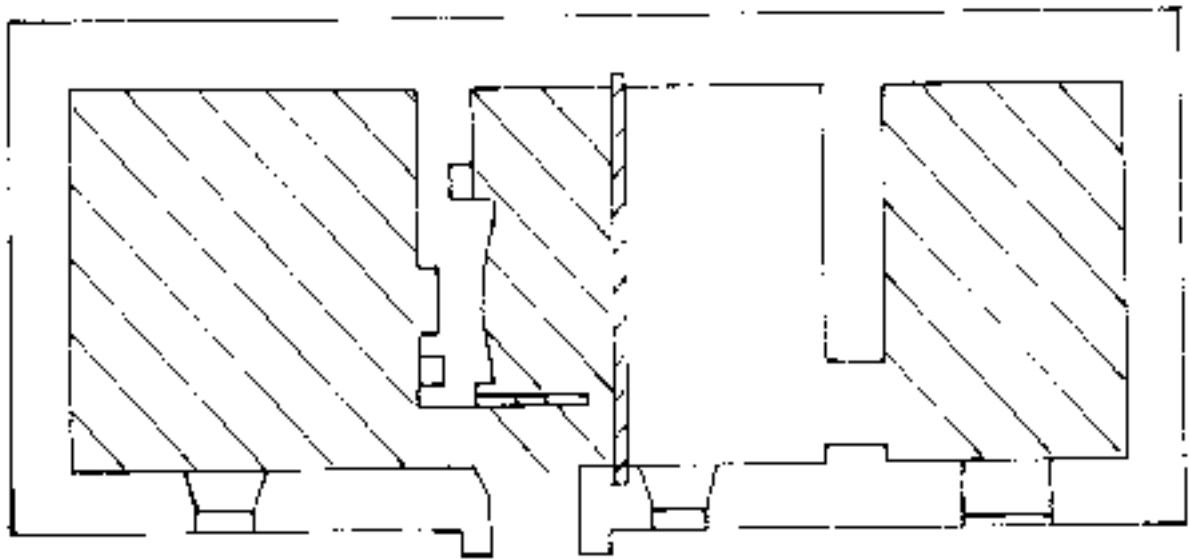
**Figure 11: Plan of a typical three unit hearth-lobby house from Gortalughany, Co. Fermanagh  
(Gailey 1984, 167)**

3.4.4 The building was extended to the north-east and south-west to emulate the traditional vernacular cottage common in the area. This must have occurred during the late nineteenth or early twentieth century as Mr Keogh states the house always comprised a three unit construction when he resided within it. A number of modifications to the structure, principally the erection of internal brick divisions are noticeable during this period of use, most notably the construction of a 'jamb wall' (in this case Context No. 209) which separates the kitchen area from the entrance into the structure (Gailey 1984, 165). By extension and internal modification, the structure was turned from a series of small single residential units into a typical 'hearth-lobby house' (Gailey 1984, 167; Figures 11 and 14).

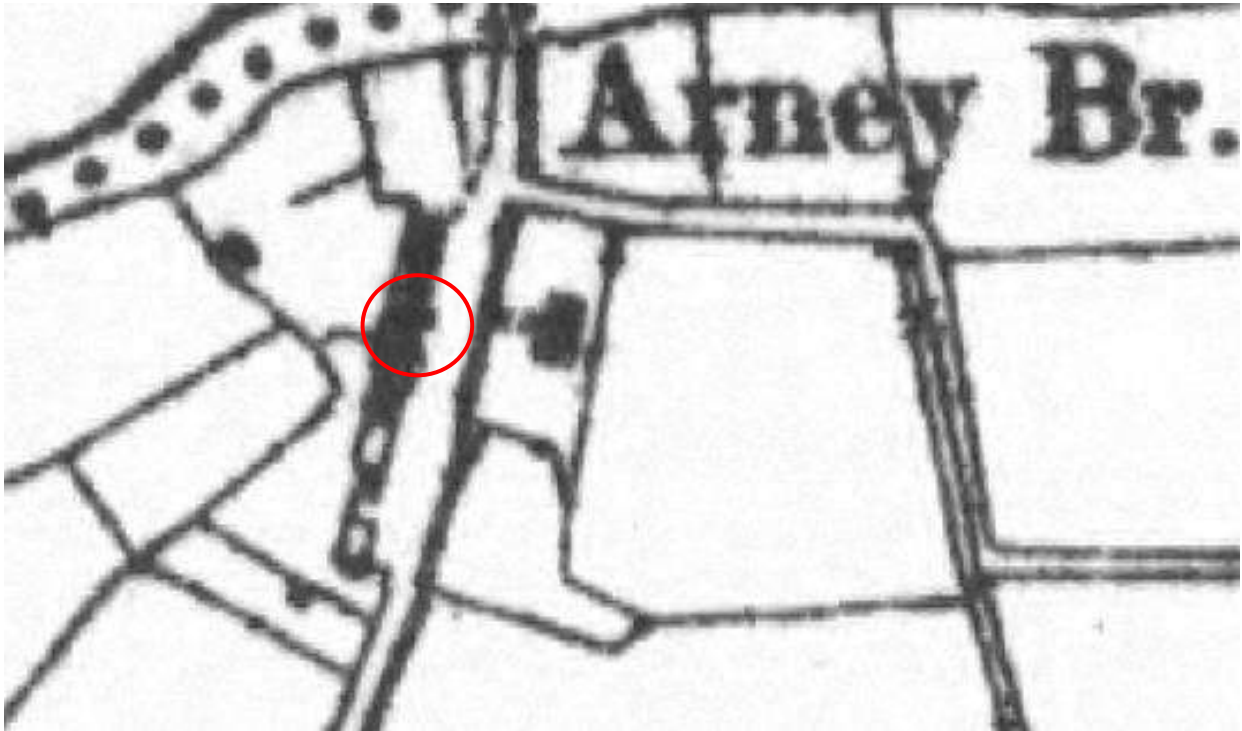
**Figure 12: The approximate location of Trench Two as depicted on the c.1907 OS map. It is possible that the structure shaded white is the byre of the house, suggesting that the modifications to the structure had occurred prior to c.1907.**

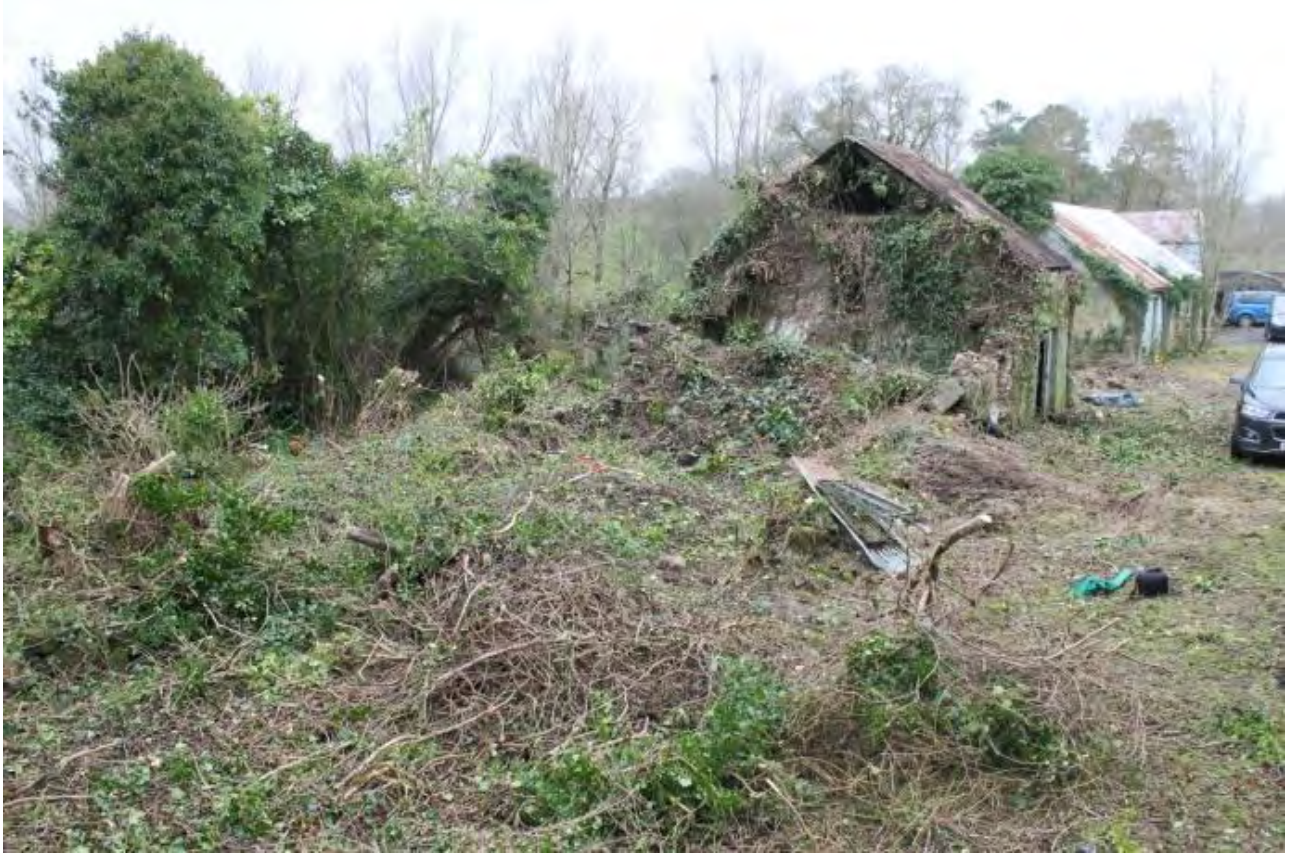
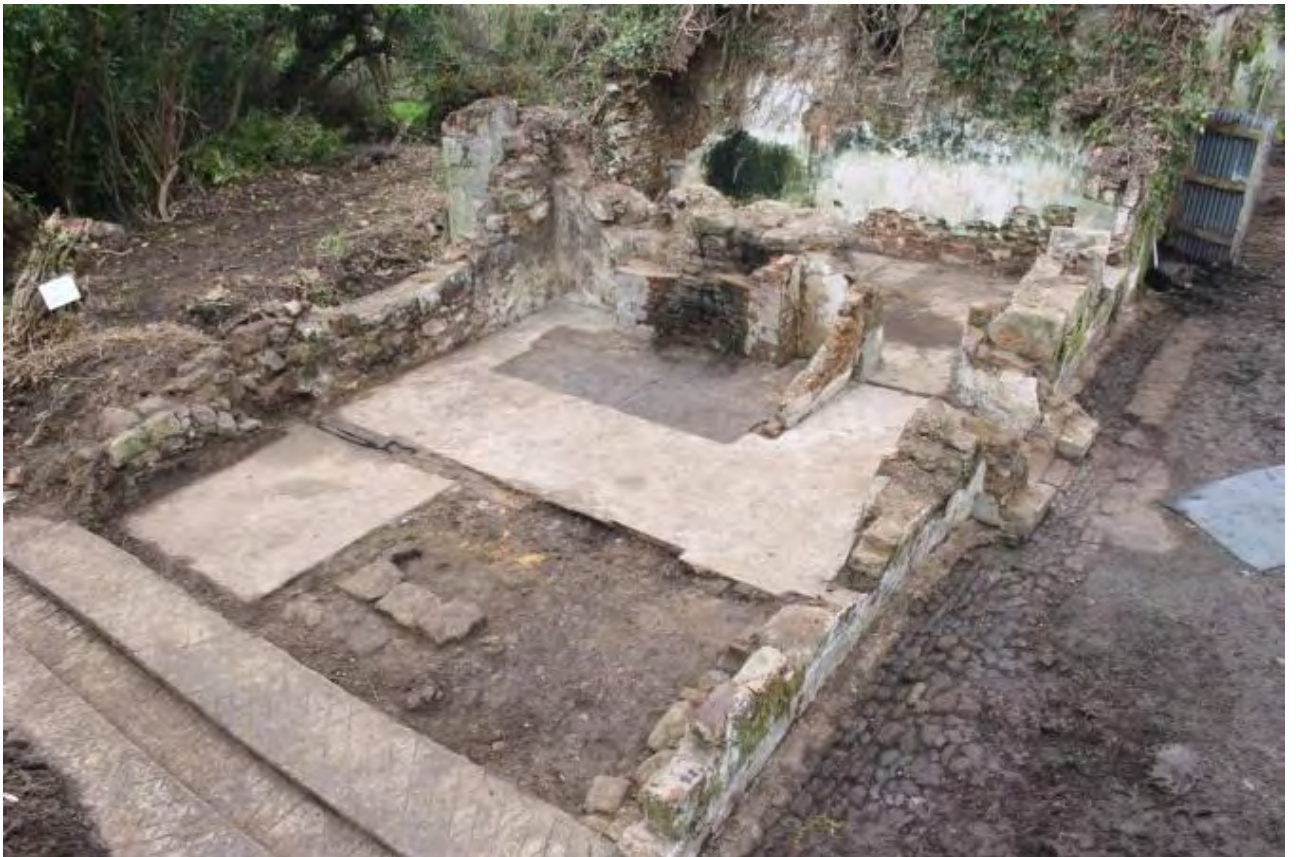
**Plate 10: Overview of Trench 2, showing a pre-excavation view (top) and a post-excavation view (bottom).**

- 3.5.2 The stratigraphically latest deposit encountered during the excavation of this area was a mixed deposit of organic matter and rubble (Context No. 201). Despite the make-up of this deposit being comprised of several distinct layers and deposits, it was mechanically removed as one stratigraphic unit. The rubble and organic deposit (Context No. 201) varied in thickness from a maximum of 1.5m in the northern part of the building to a minimum of 0.4m in the south.

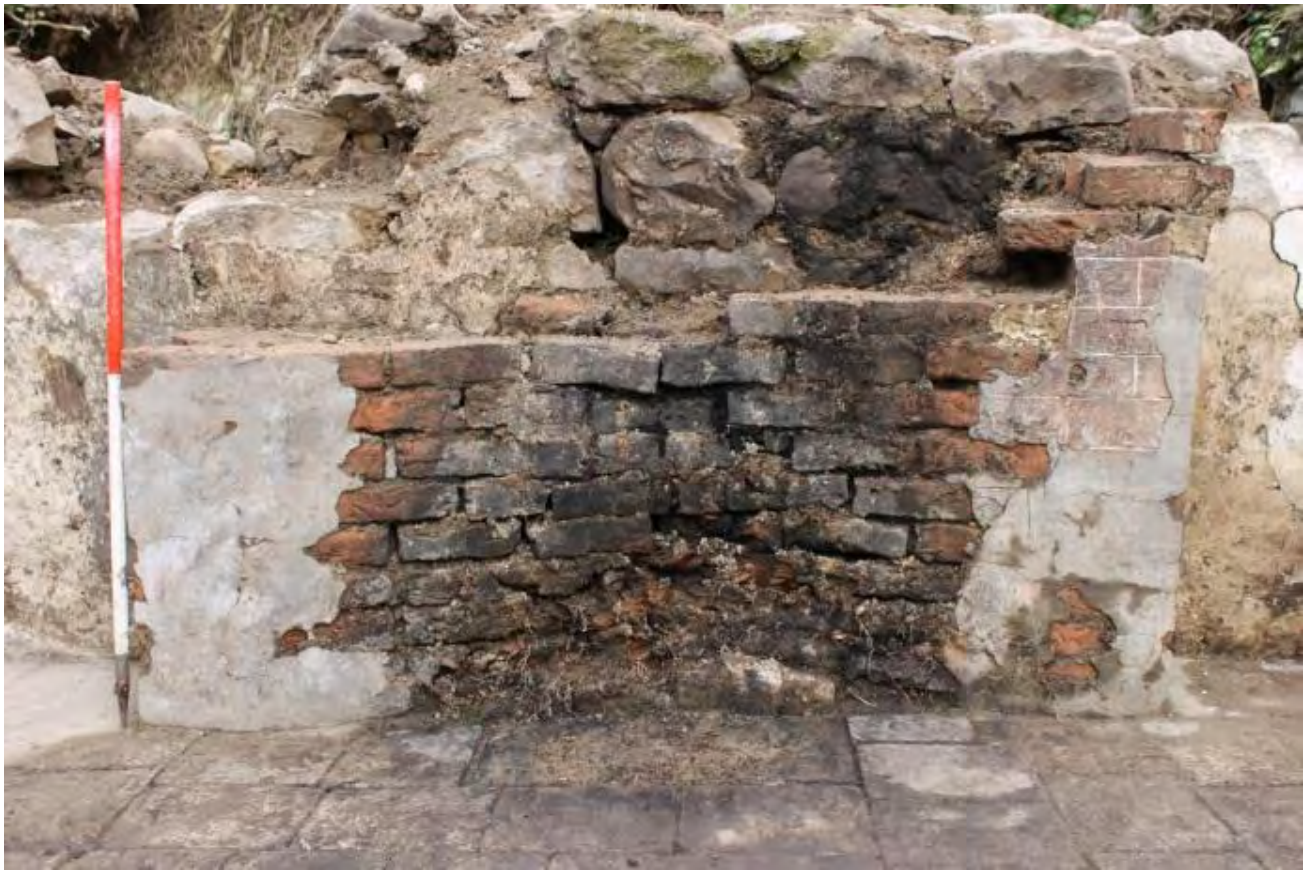
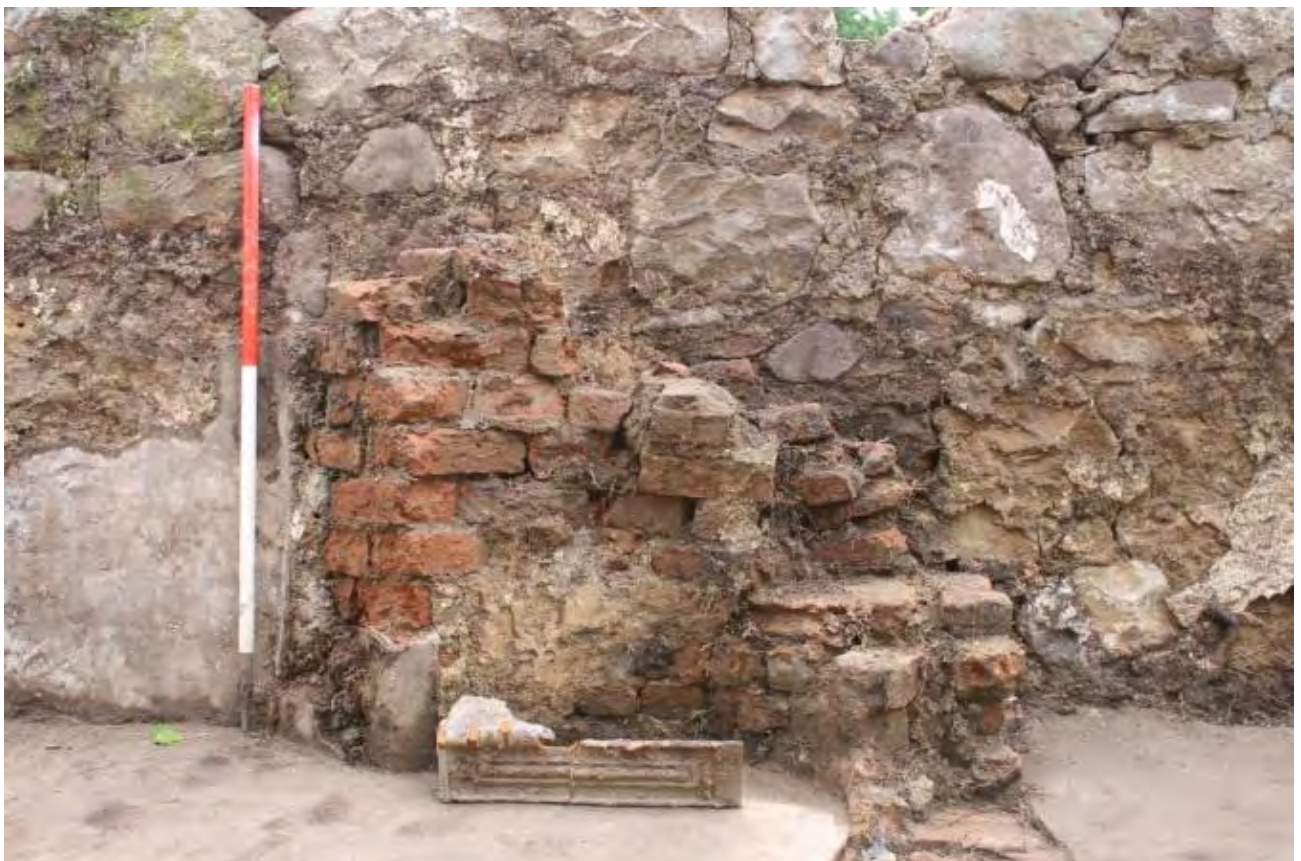
**Plate 11: Main fireplace (Context No. 207) (top) and fireplace in the parlour (Context No. 206) (bottom).**

- 3.5.4 The middle room was the original extent of the house, with the cottages on either side being purchased to extend the living space in both directions, for a parlour and bedroom to the north-east and two bedrooms to the south-west (Myles Keogh *pers comm.*). It is not possible to tell when exactly this period of renovation and modification took place, but it appears that very little other than the exterior wall of the cottages (Context No. 217) remains original. The exterior walls of the structure (Context No. 217) were on average 0.5m thick and consisted of large rounded boulders bonded with a crumbly, beige coloured lime mortar. Through the duration of the excavation, this mortar became increasingly weathered, having previously been protected from the overlying modern detritus (Context No. 201). The original flooring was replaced with cement (Context Nos. 212, 213, 214 and 215), evidenced by the fact that it respects the new internal divisions that were constructed (Context Nos. 208, 209, 210 and 211) being single brick walls instead of the 0.5m thick stone walls. The two fireplaces (Context Nos. 206 and 207) appear to also have been constructed at this time as they appear to sit directly upon the cement floors of the structure. The smaller of the two (Context No. 206) was built in the northern extension, in what Myles Keogh described as the parlour of the house, which was a locked room and kept for guests. The larger (Context No. 207) was in the middle room of the house. A semi-circle of burning damage to the paving stone is evident in front of this fire that is absent in the parlour, indicating that this fire was lit with much higher regularity, suggesting that this is the main living area of the house.

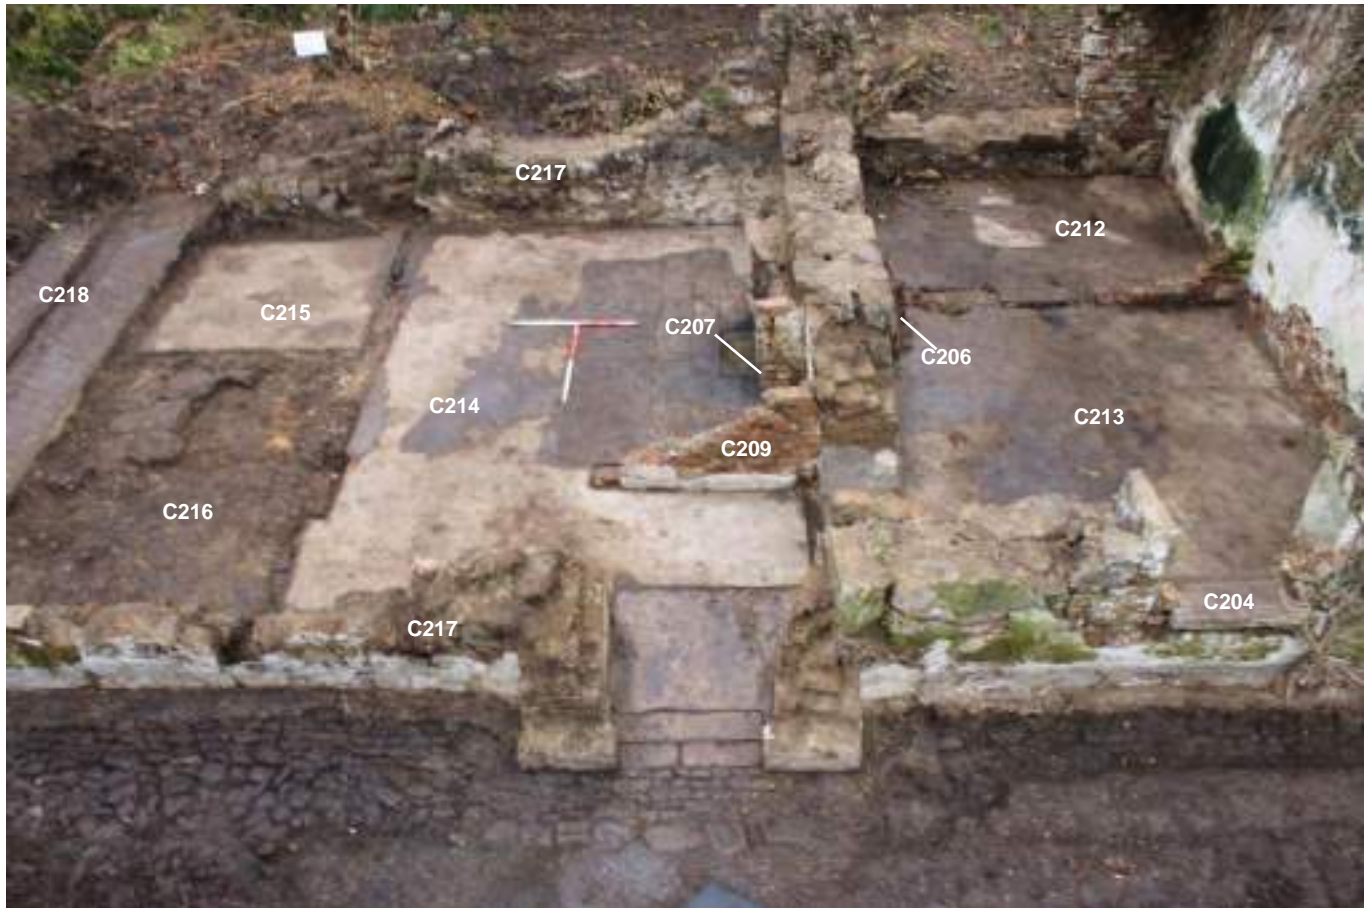
**Plate 12: Post-excavation view of Trench Two, looking west.**

- 3.5.6 No attempts were made to excavate any of the floor levels within the structure, so no features or deposits that might relate to an earlier phase of activity in the house was encountered. However, in one of the rooms in the south-west extension, there was no cement floor rather a mid-brown sandy-silt deposit (Context No. 216) was present. It is likely that this deposit (Context No. 216) represents a leveling deposit for the floor material that was used here. Myles Keogh recalls that this room of the house was originally paved with flag stones and that have since been robbed out and reused. The fact that only the wall bases remain for the internal dividing walls (Context Nos. 210 and 211) would suggest that salvage of reusable building materials was carried out here following the abandonment of the structure. The exterior of the structure was cobbled by a layer of rounded stones (Context No. 222) which averaged 0.2m in length. A deposit of cement (Context No. 220) covered both the base of the exterior wall (Context No. 217) as well as the cobbles (Context No. 222) thus no stratigraphic relationship between the wall and the cobbles was possible to identify.

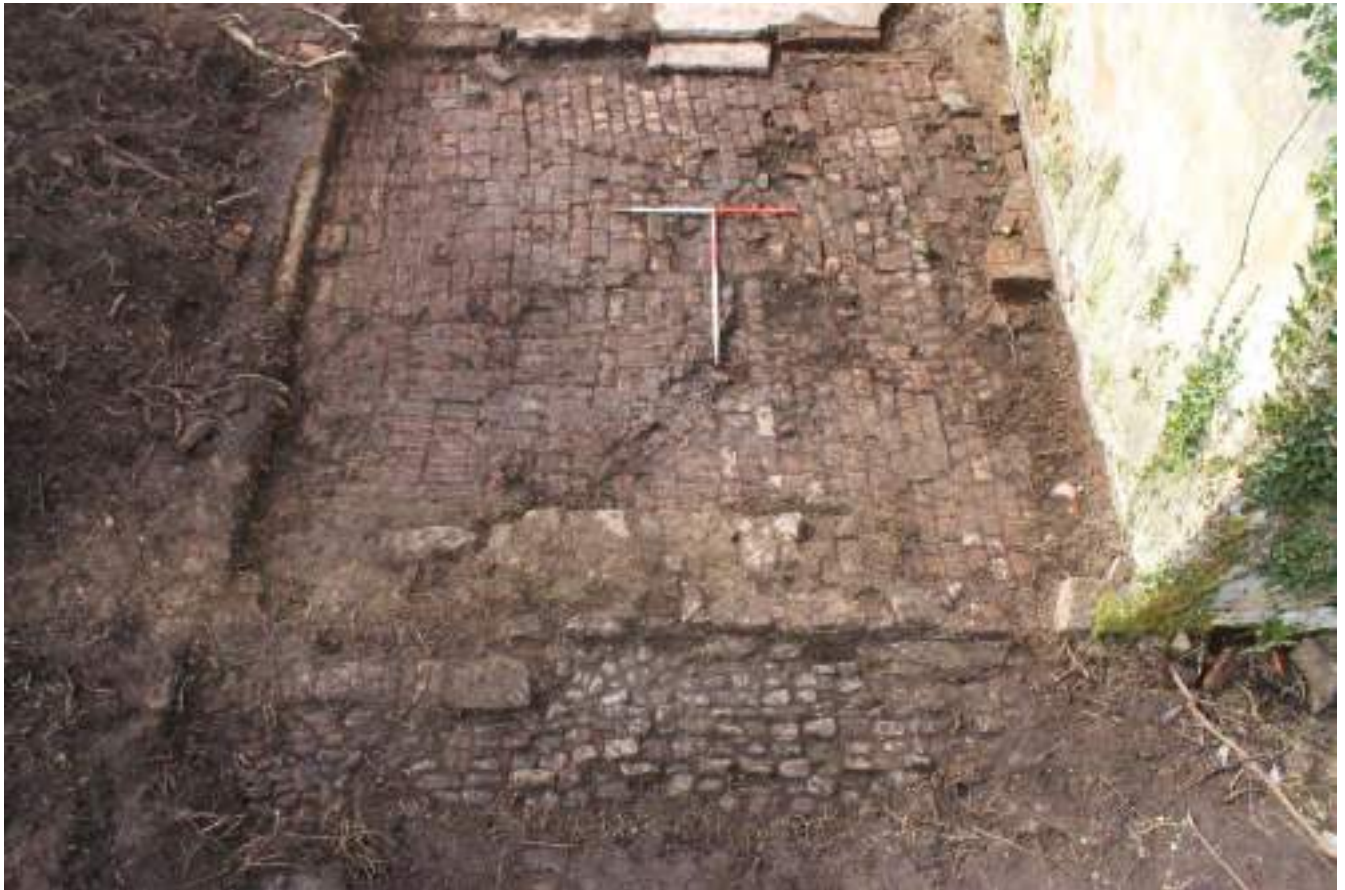
**Plate 13: Post-excavation shot of Trench Three showing the brick floor and structural elements of the building (Context No. 302), looking west.**

- 3.6.3 Both the cement floor (Context No. 305) and the base of the fireplace (Context No. 304) appeared to be constructed directly upon the brick floor of the structure (Context No. 302). The base of a fireplace (Context No. 304) was encountered along the northern wall of the structure. This feature was constructed of brick and survived to a single course high. The fireplace (Context No. 304) measured 1.3m (north/south) and was the only internal feature exposed within the structure. A noticeable 'step' from the brick floor (Context No. 302) to the cement deposit (Context No. 305) was noted, although the location of spoil here made further investigation of this deposit problematic. The exterior wall of the structure (Context No. 303) was comprised of rounded boulders bonded with a beige coloured mortar and was on average 0.5m thick. The wall survived to a single course high, with a maximum recorded

height of 0.42m above the brick floor (Context No. 302). Removal of the overburden (Context No. 301) in the exterior of the structure revealed a deposit of cobbles (Context No. 306) which appears to be a continuation of the cobbles encountered during the excavation of Trench Two (Context No. 222).

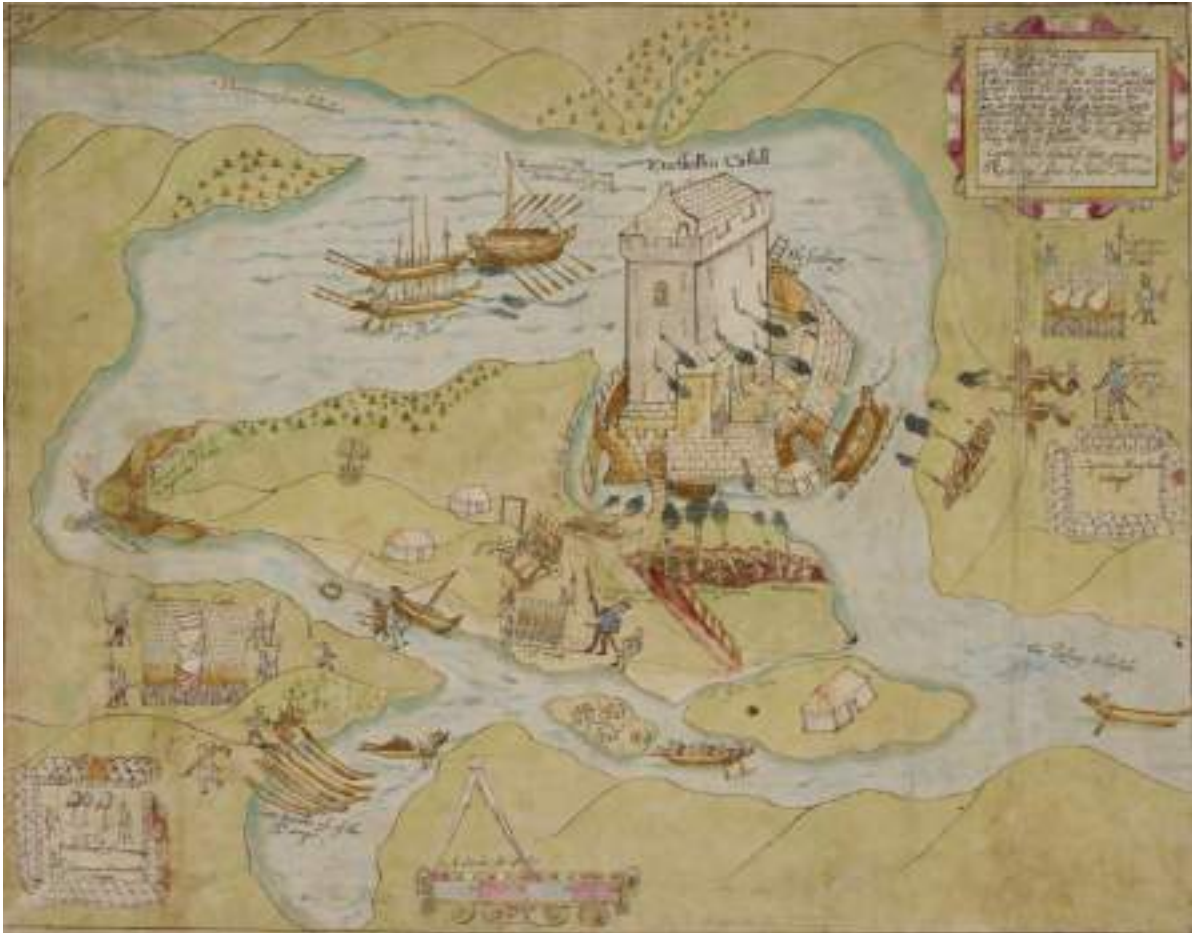
**Figure 16: Depiction of the Crown capture of Enniskillen Castle, February 1594, as drawn by John Thomas (BL Cotton Augustus I.ii.39)**

- 4.3.3 From Castle Skea Dowdall and his men were to prosecute an end to the war with Maguire and capture his main castle at Enniskillen. Subsequently, on February 2nd 1594, Captain John Dowdall wrote to the Lord Deputy in Dublin stating that after a short siege he had captured Enniskillen Castle from the 'rebel' Hugh Maguire (*Cal. S. P. Ire. 1592-96*, 207-208). This event gave rise to the now famous colour drawing of the capture of Enniskillen Castle drawn by John Thomas, soldier servant of Dowdall's (BL Cotton Augustus I.ii.39).

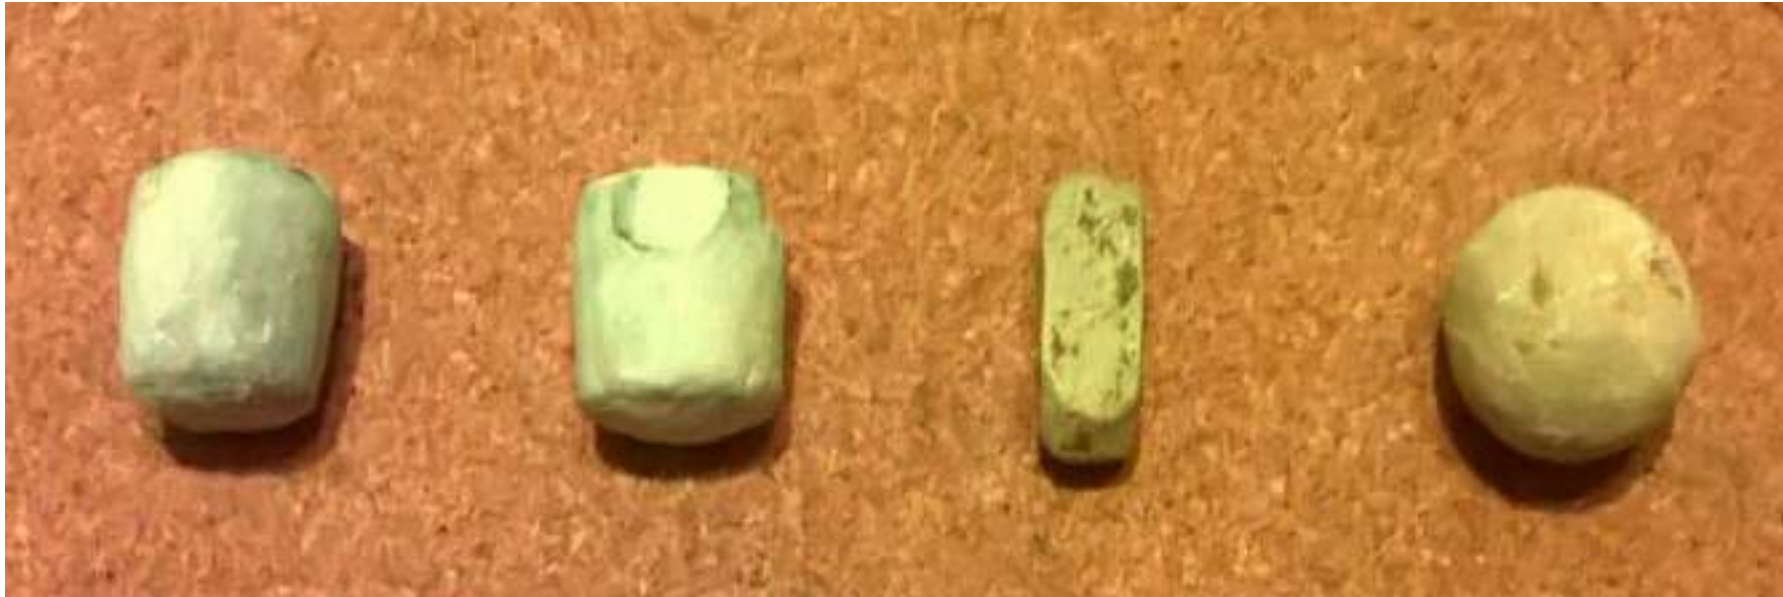
**Plate 14: Four lead shot from the battlefield site. The three elongated lead shot to the left are known as slugs, or plugs, and were made to pierce armour. This type of shot is believed to have predominated amongst the cavalry. The rightmost shot is a more normal round lead shot included to show the difference in shape – it would have been in use by the infantry.**

4.5.2 Much more compelling evidence was discovered at the Ford (Area 2, the land belonging to Maurice Owens and Reggie Cunningham). Fields on both sides of the river were surveyed, with lead shot being found, but much more important was the presence of lead slugs in both fields. Slugs are non-spherical bullets, created by hammering larger calibre shot into smaller calibre (Foard 2009, 9). The advantage here was being that a smaller, lighter gun could fire a bullet with the same penetrative stopping force, while being much more maneuverable than a standard musket. Slugs were made for military purposes only; they were specifically designed to penetrate armour. It is extremely unlikely that these 3 slugs found across both these fields are representative of anything other than the Irish attack on the English forces trying to cross the River Arney.
