Data Structure Report No. 103

Excavations at Arney, Co. Fermanagh

**Excavations at Arney, Co. Fermanagh**

**AE/14/01E**

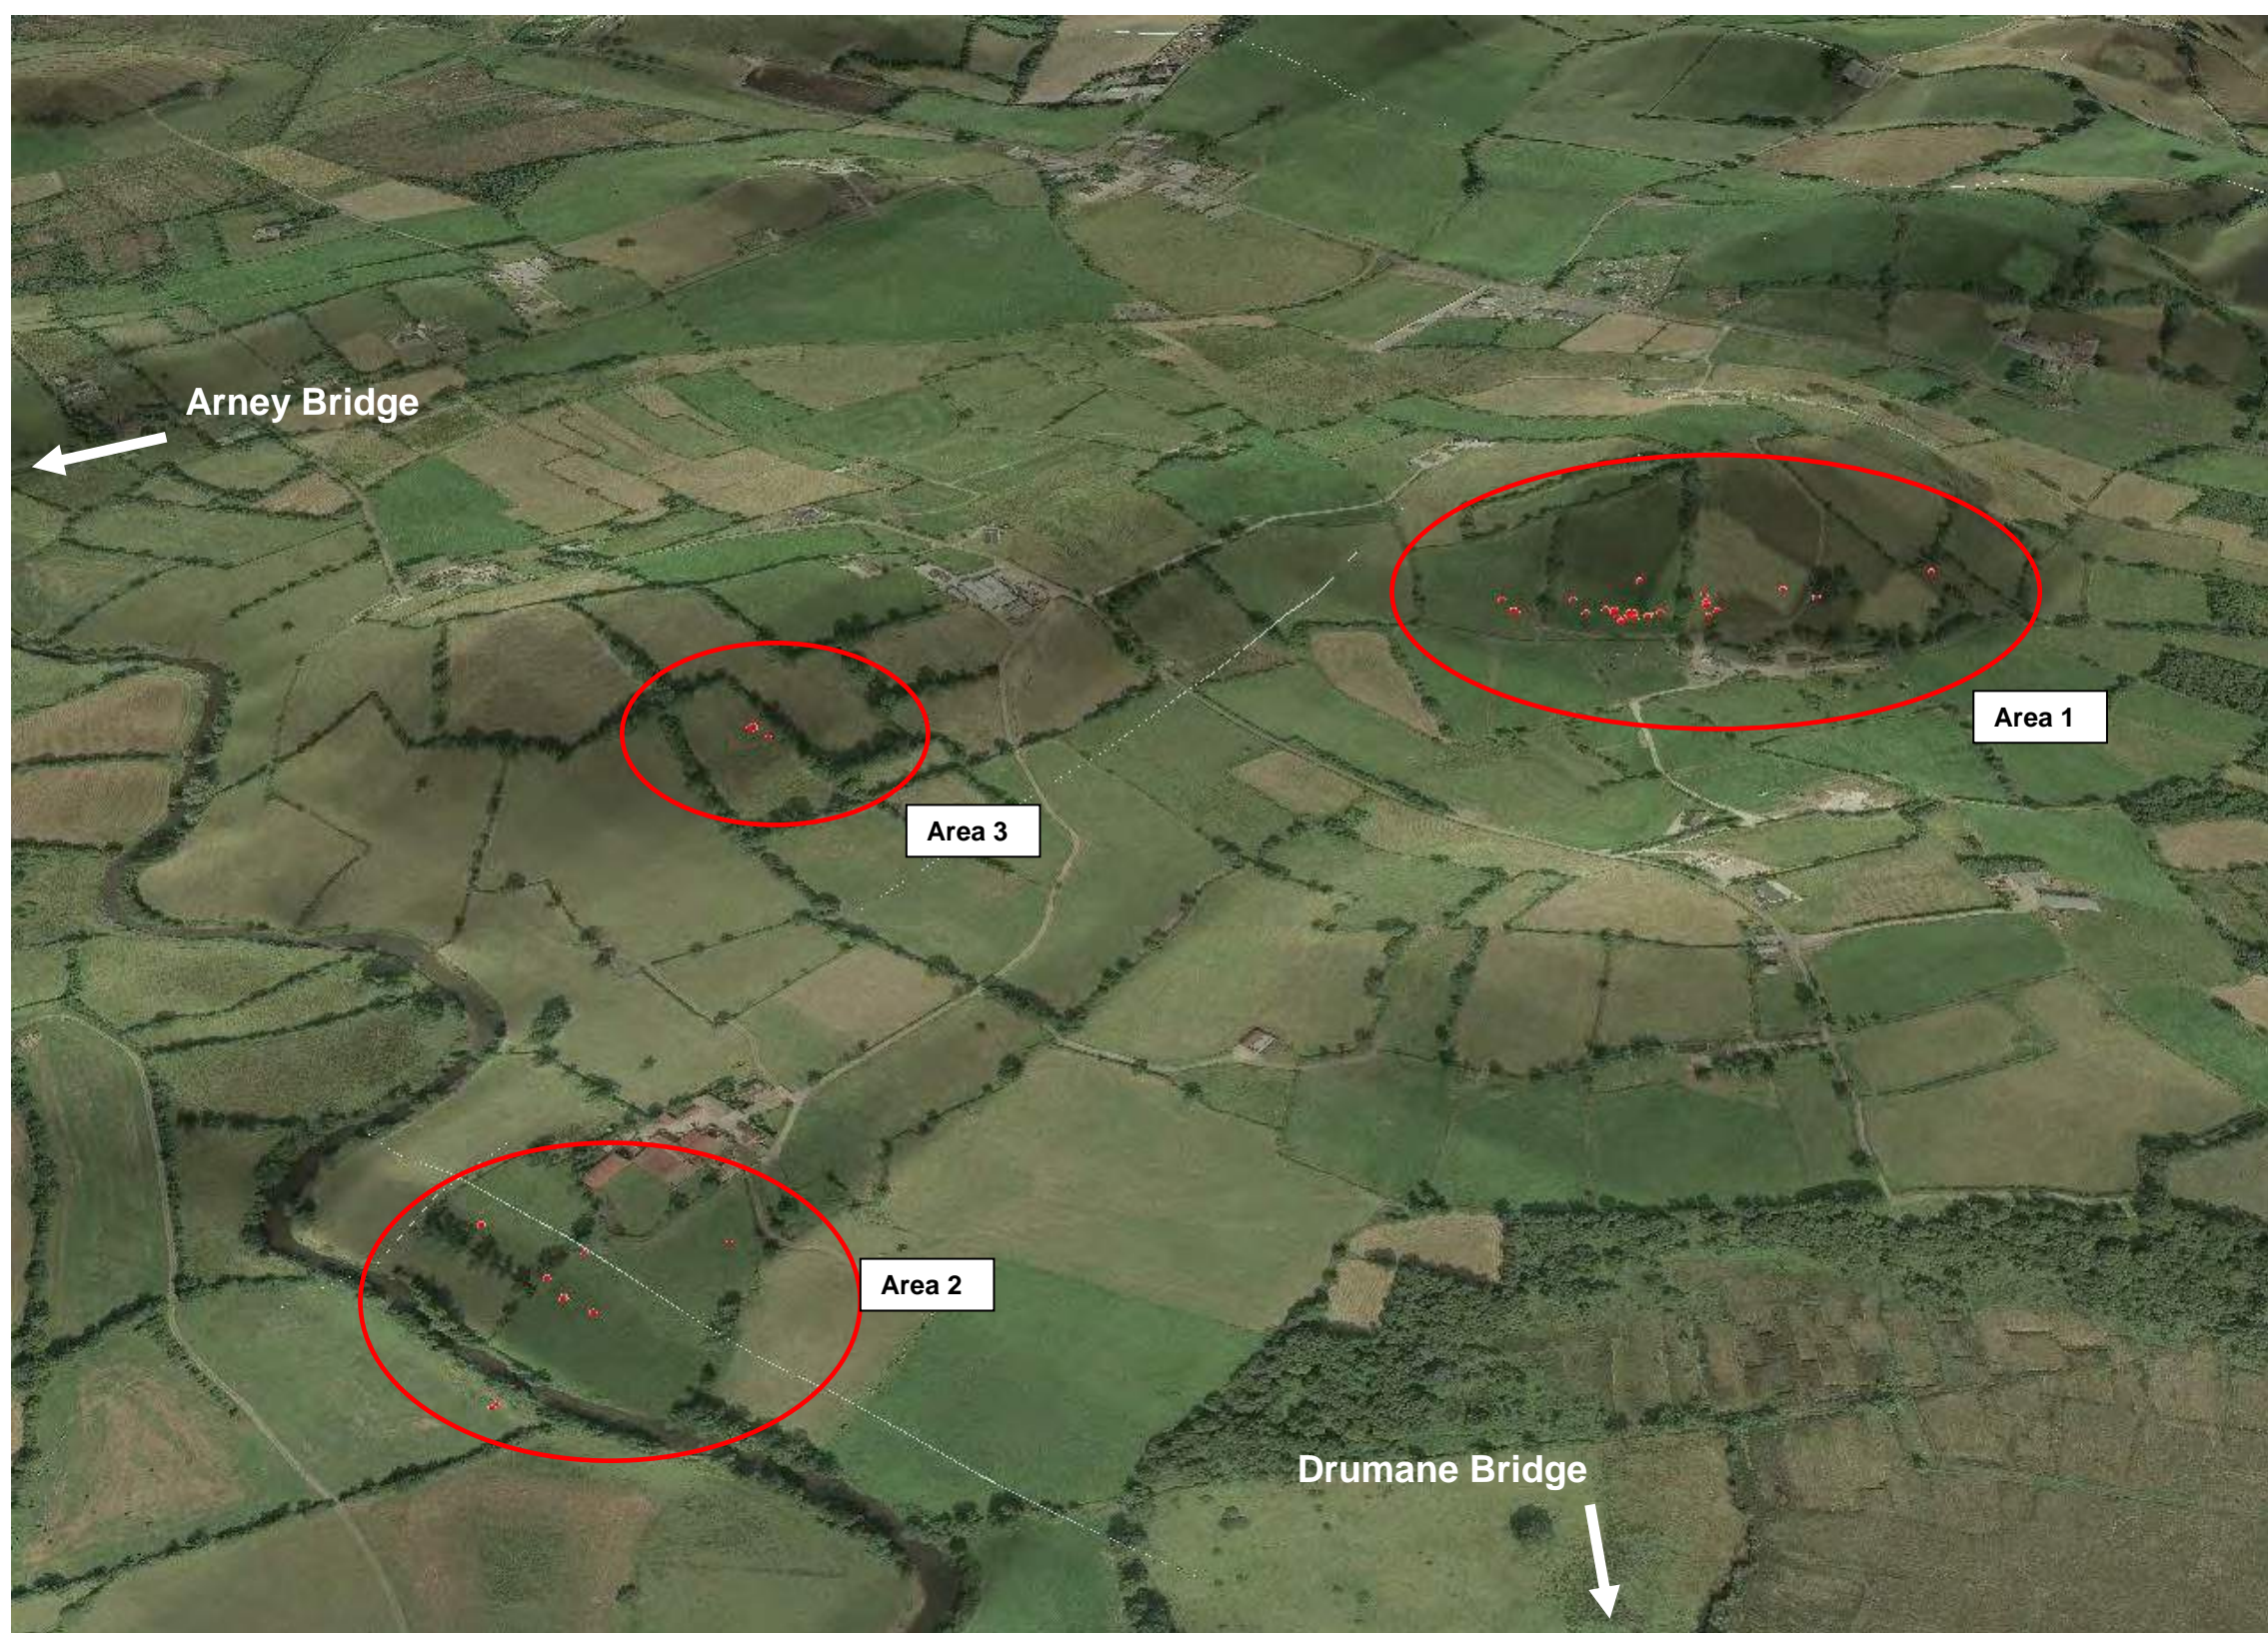
Figure 19: Oblique aerial view of the metal detection find spots looking from the south-east onto the north-west. Ortho-rectified aerial photographs, 2006, draped over Digital Terrain Model visualised in ArcScene 10.2.  
(Image prepared by Dr Siobhán McDermott, Centre for Archaeological Fieldwork, QUB)
